SUMMARY OF GEOLOGIC CONDITIONS AT BLAKE ESTATE
Kensington, California

Mark Eischeid
LA 299
Supervising Instructor: Professor Patricia Lindsey
December 16, 1999

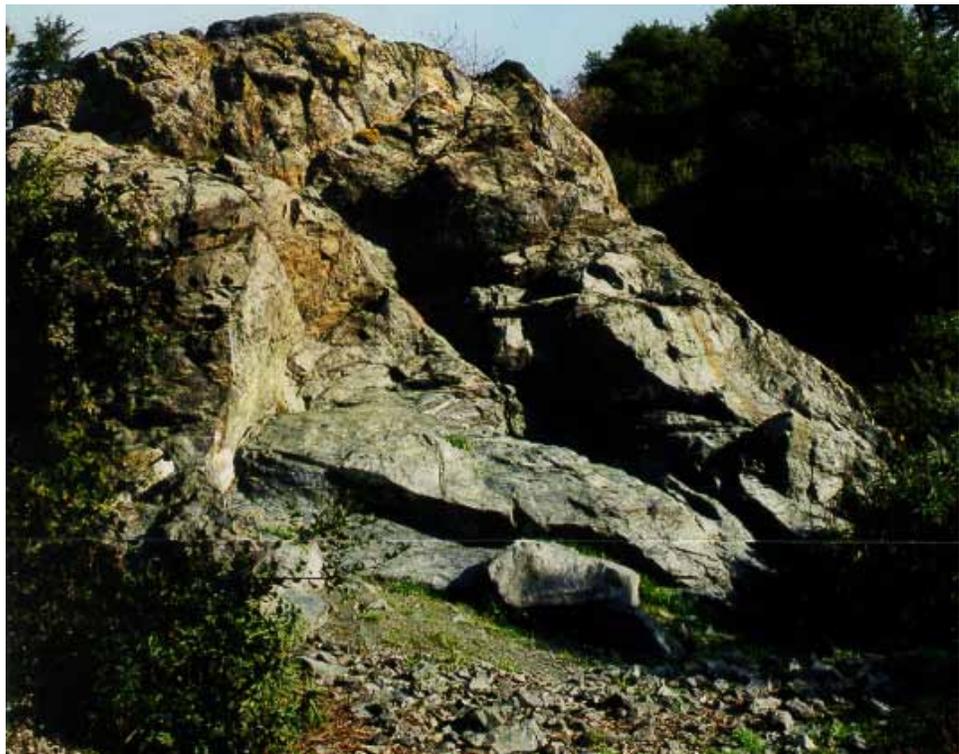
tainty regarding the glaucophane schist outcrops on the site (Davis and Pabst 1960). In referring to the large glaucophane schist boulder in the West of the House area (Figure 4), Davis and Pabst explain:

Figure 4: View of the south face of the large lawsonite-bearing glaucophane schist boulder in the West of the House area. Note the rock debris on the ground which may support the appearance of possible past quarrying seen on the rock face.

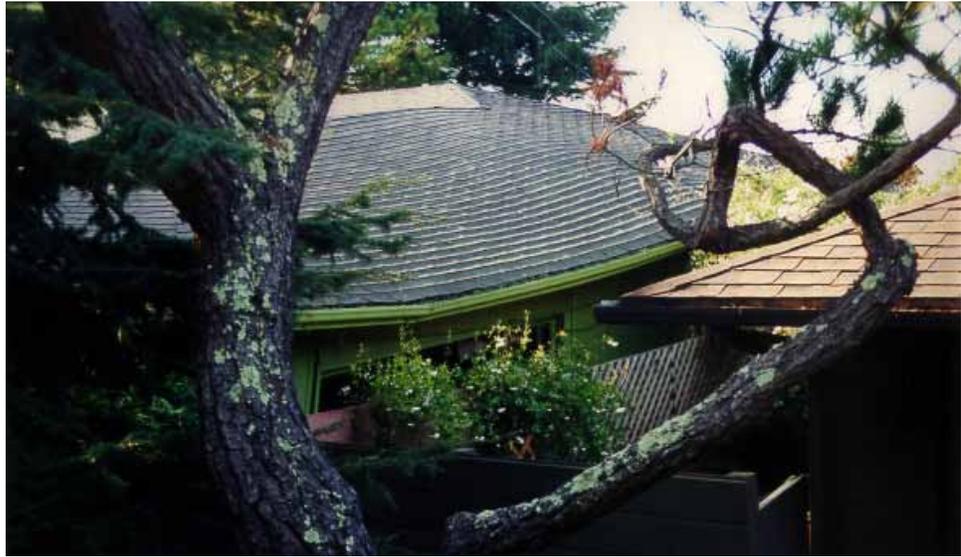
Geotechnical engineering and engineering geology investigations performed by local consultants in the vicinity of Blake Estate describe an area affected by landslides with distress to curbs, driveways, sidewalks and homes possibly caused by landslide movement or fault activity (Abel R. Soares and Associates 1978) and local landsliding (Geotechnical Engineering, Inc. 1996). In addition, the Blakemont slide has likely caused deformation to the asphalt and homes along Highgate over the past several years (John Norcross, personal communication, 1999) (Figures 5, 6, and 7).

Figure 5: View of landslide-induced distress to the residence at 18 Highgate Road. Note the warped roof and cracks along the side of the residence.

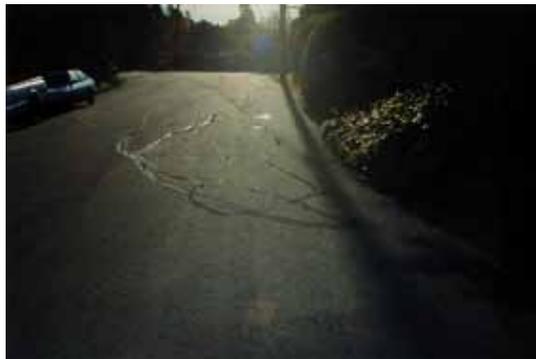
Figure 6 (above): View to the southeast along Highgate Road. The residence at 18 Highgate Road is to the right. Note arcuate cracks in the asphalt, which represent small-scale deformation within the Blakemont landslide.

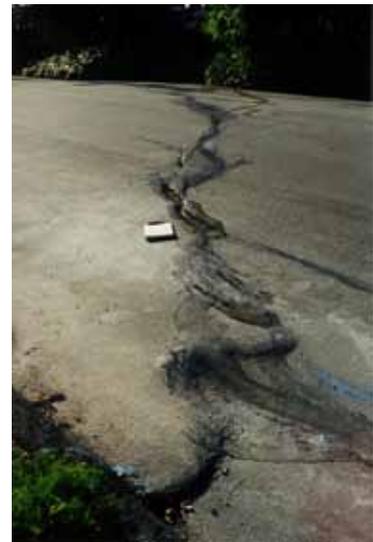
Figure 7 (right): View to the south across Highgate Road near 16 Highgate Road. Crack in asphalt is up to 3 inches wide. A driver of a car passing by while I took this photo said that the road was resurfaced two years ago. Clipboard for scale.

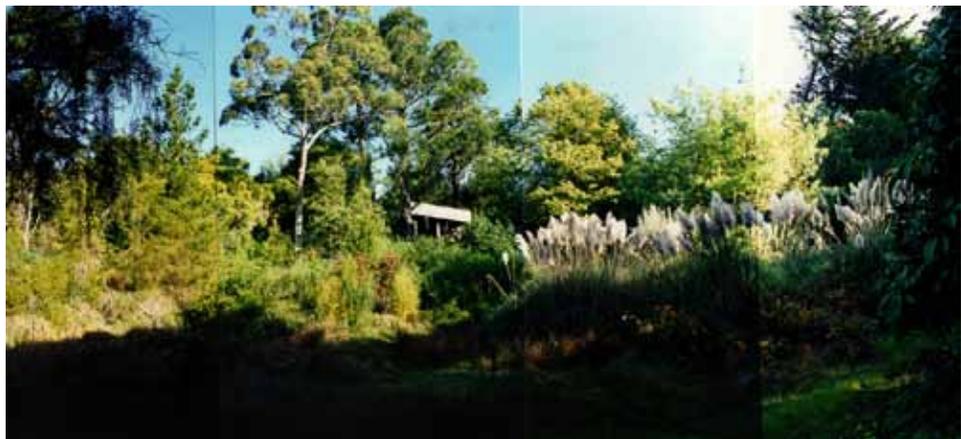
One interesting feature of the lower half of the site is the Australian Hollow (Figure 8). I hesitated to characterize the steep slopes and marshy area of the Australian Hollow as a landslide because I could not locate the toe of what should be a sizable deposit, considering the steepness of what would be the headscarp and lateral margins of the slide. My guess is that this feature had been a small quarry. Mr. Blake ran a quarrying business both before and after the Blakes lived on this site. According to Mr. Norcross (personal communication, 1999), the Blake site was originally intended as a quarry site. I can only guess that perhaps this small quarry was used for rock on the Blake property or for nearby properties and/or roads.

Figure 8: View to the north of the Australian Hollow area. Note cattails in the right midground, which favor moist to wet soil conditions. These soil conditions are likely a function of the bowl-shaped topography and the Australian Hollow spring. Steep slopes in the background are up to 90% grade.

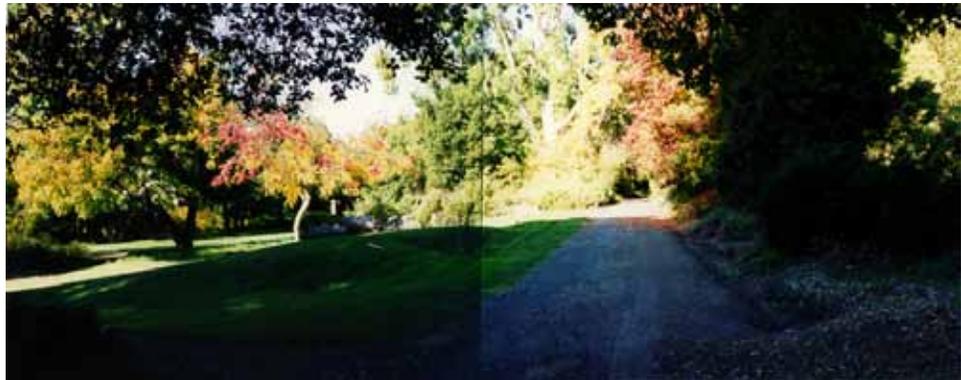
Figure 9: View to the northwest across the lawn near the Cut-Flower Garden. This view looks along the approximate location of Lienkaemper's downslope Hayward fault trace.
