SUMMARY OF GEOLOGIC CONDITIONS AT BLAKE ESTATE
Kensington, California

Mark Eischeid
LA 299
Supervising Instructor: Professor Patricia Lindsey
December 16, 1999

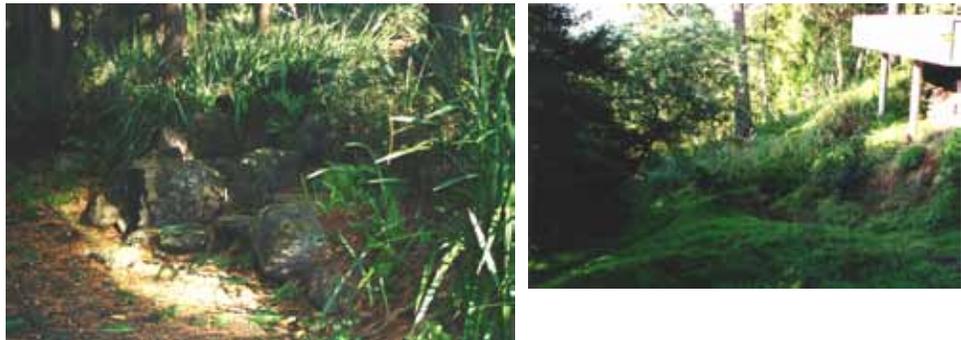
Garden spring is piped into the grotto, travels along a concrete-lined runnel and into the reflecting pool before it is finally piped into the northwest stream (Figure 10). As previously discussed, this spring may be a function of the Hayward fault. The perennial spring in the Australian Hollow outlets from a pipe placed in the side of the slope (Figure 11). Mr. Norcross was able to pipe the water produced from the spring into a plastic reservoir throughout the duration of the drought in the late 1980s and early 1990s (personal communication, 1999). I have previously suggested that quarrying may have occurred in the Australian Hollow area; such quarrying may have exposed the spring located there.

Figure 10 (left): View of the Formal Garden spring that drains through the grotto and into the rectangular pool.

Figure 11 (right): View of the Australian Hollow spring, which is hidden in the lush grasses below the elevated driveway seen at right.
